BMW Cruise Control Actuator 1985 to 1996 Technical Data

November 26, 2005

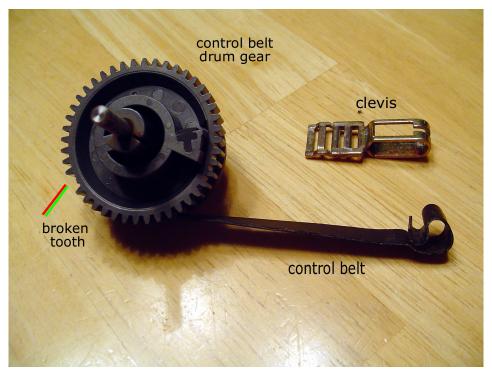
The cruise control actuator will seem to work only intermittently or partially when a tooth is broken in the gear driving the control belt drum. This is because the control unit will attempt to operate the actuator, but gets inconsistent feedback from the potentiometer when the drive encounters the broken tooth.

Figure 1 - Control belt drum with broken tooth

When the inconsistent feedback is received the control unit will eventually give up and disengage. A similar effect is noticed when the potentiometer resistance surface or wipers become pitted or burned.

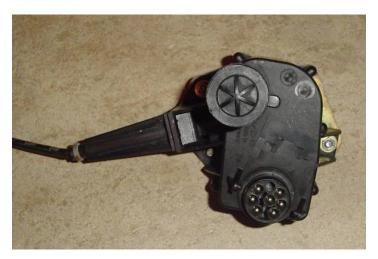
The cruise control actuator is enclosed in a two part plastic housing. The throttle control cable protrudes through a fixture on the top half. A round male electrical connector for the control cable is also located on the top half.

Figure 2 - Actuator top view

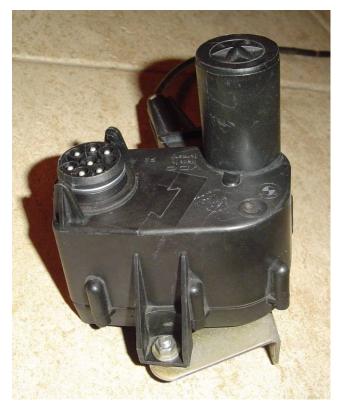
Figure 3 - Actuator side view

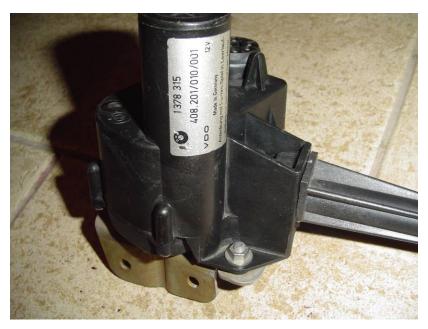
Figure 4 - Actuator side view

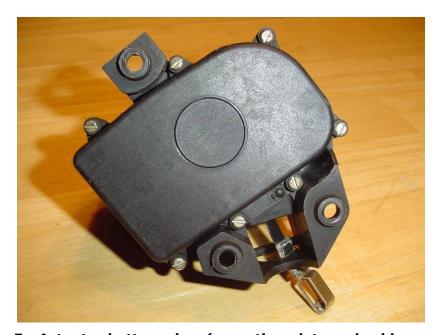
Figure 5 - Actuator bottom view (mounting plate and cable removed)

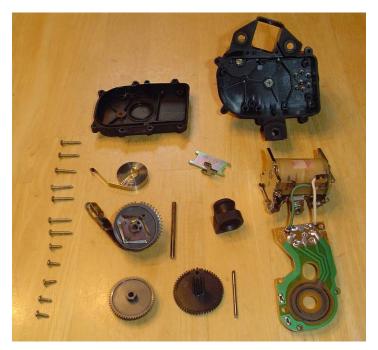
Figure 6 - Internal components

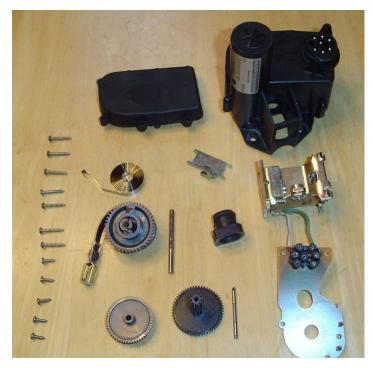
Figure 7 - Internal components (alt. view)

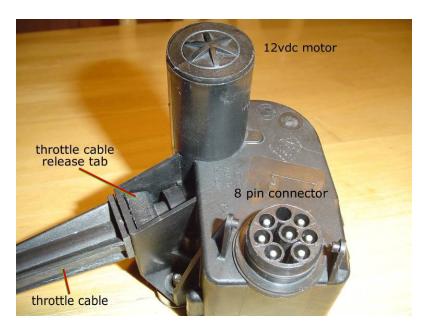
The throttle cable may be separated from the cruise control actuator. This may be accomplished while the cruise control actuator is in the automobile.

Figure 8 - Throttle cable release tab

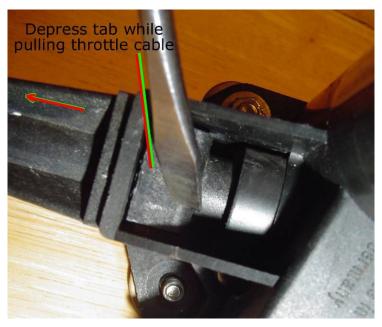
Figure 9 - Depress tab and pull cable

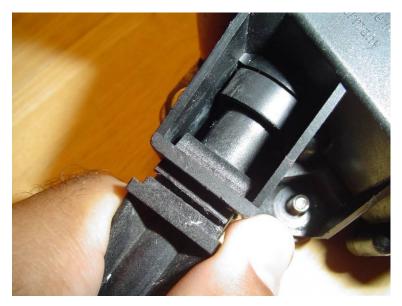
Figure 10 - Sliding out throttle cable

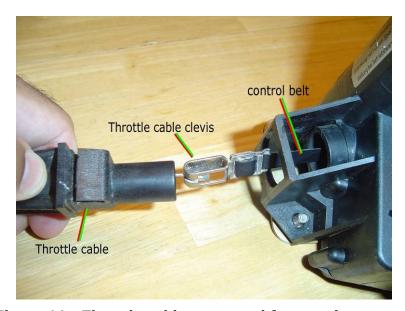
Figure 11 - Throttle cable separated from cruise control

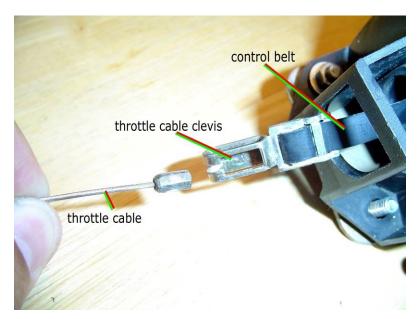
Figure 12 - Throttle cable disconnected

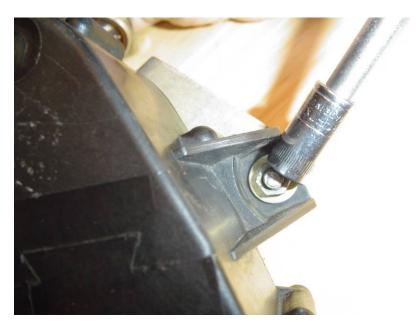
Figure 13 - Remove mounting plate nuts

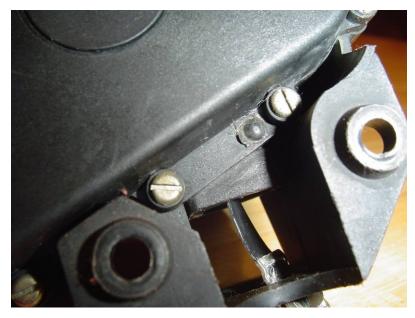
Figure 14 - Remove shell perimeter screws

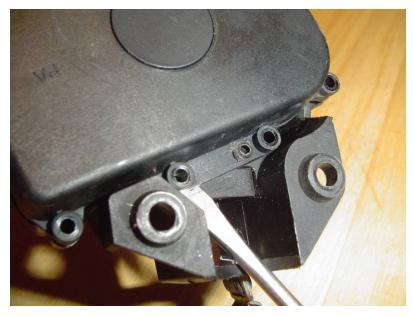
Figure 15 - Using screwdriver to separate shell halves

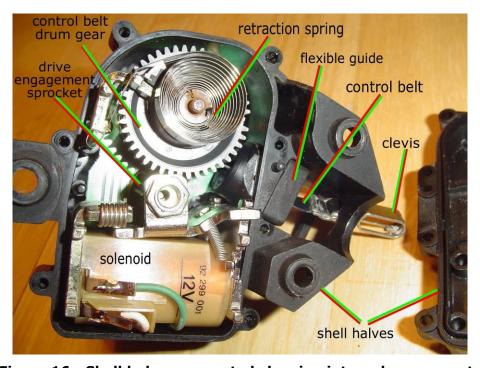
Figure 16 - Shell halves separated showing internal components

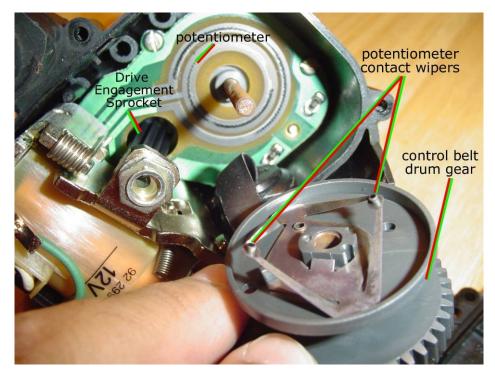
Figure 17 - Control belt drum gear and retraction spring removed

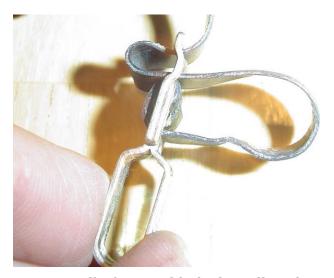
Figure 18 - Detail of control belt threading through clevis

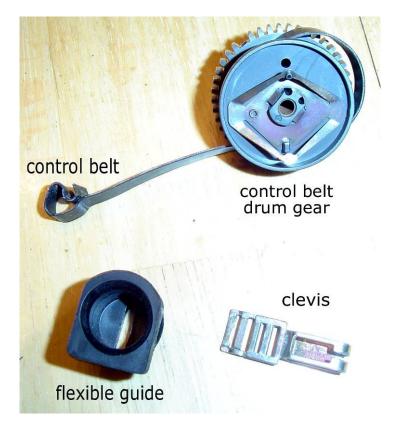
Figure 19 - Detail of control cable drum gear, flexible guide, and clevis

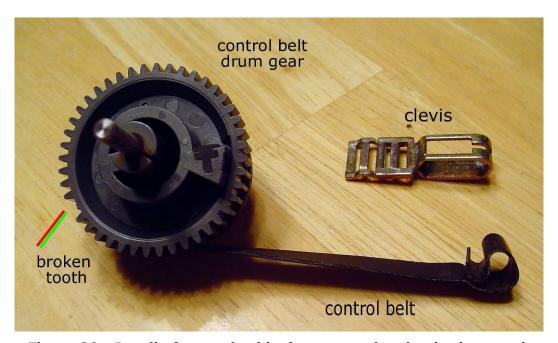
Figure 20 - Detail of control cable drum gear showing broken tooth

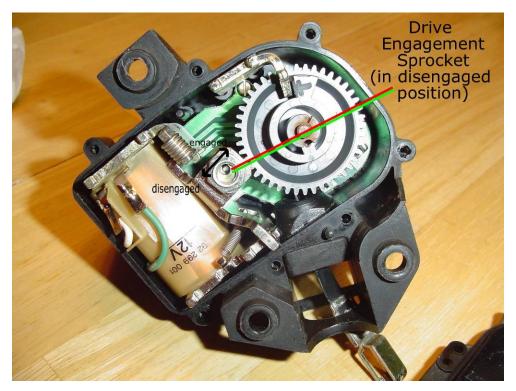
Figure 21 - Detail of drive engagement sprocket

The drive engagement sprocket is disengaged when the solenoid is deenergized. When disengaged, the control belt drum will turn freely. This allows the control belt to pay in or out. The retraction spring (not shown) eliminates slack.

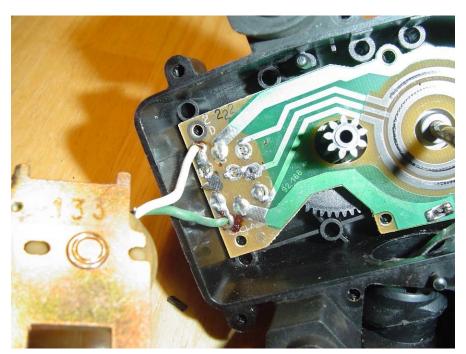
Figure 22 - View of circuit board with solenoid removed

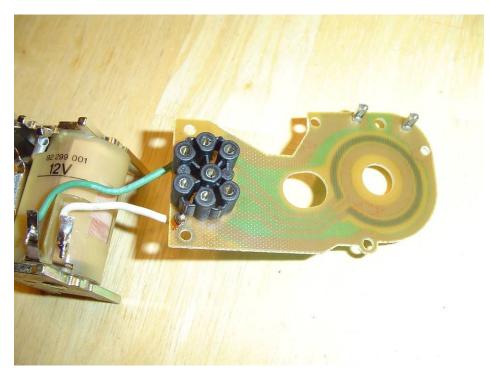
Figure 23 - Circuit board and solenoid

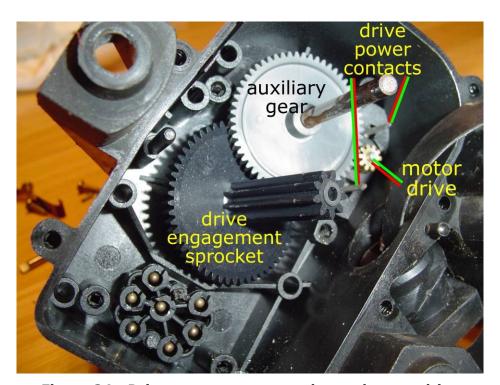
Figure 24 - Drive engagement sprocket and motor drive

When the circuit board and solenoid are removed, the drive engagement sprocket and motor drive with auxiliary gear are revealed.

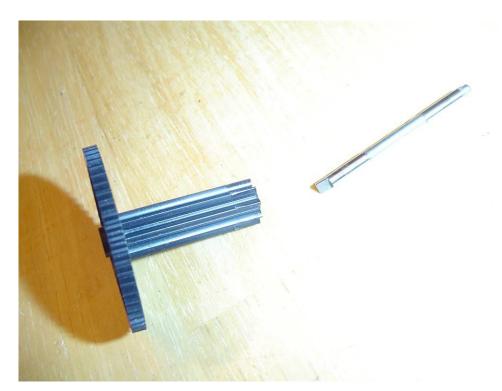
Figure 24 - Drive engagement sprocket and shaft

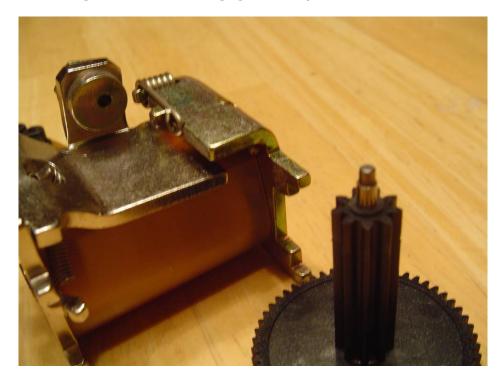
Figure 25 - Solenoid and drive engagement sprocket

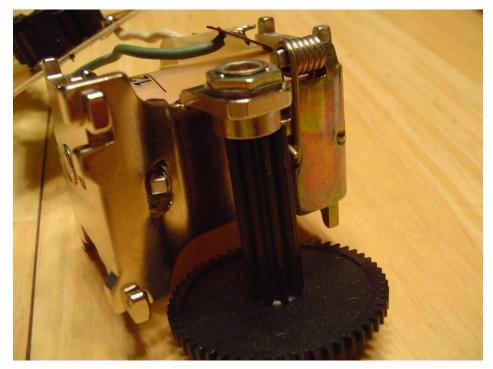
Figure 26 - Solenoid and drive engagement sprocket (partially reassembled)

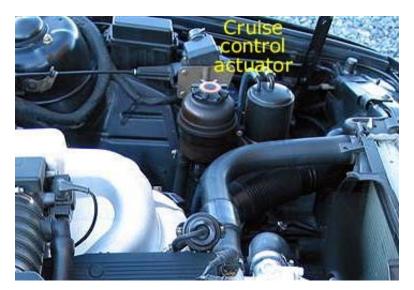
The cruise control actuator is easily removed from most E34 vehicles. For these vehicles, the actuator is located on the top of the engine compartment next to the power steering reservoir.

Figure 25 - Typical E34 mounting (non-540i)

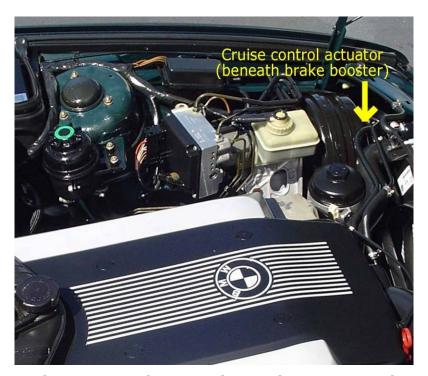
On E34 540i's, the actuator is located below and in front of the brake pressure booster. This makes it difficult to remove the actuator.

Figure 26 - Cruise control mounting on E34 540i

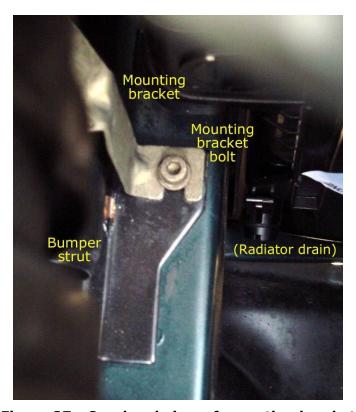
A complex option is to remove the front fascia and headlight. A simpler method is to remove the mounting bracket bolt which holds the mounting bracket to the chassis.

Figure 27 - Overhead view of mounting bracket

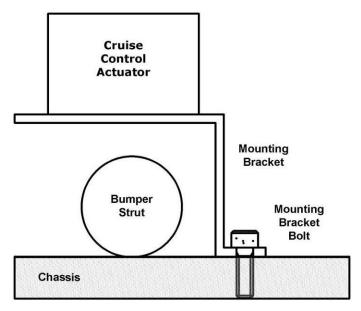
Figure 28 - Elevation view of mounting bracket

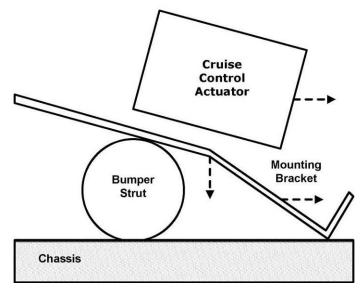
The mounting bracket may then be temporarily bent. This allows space for the actuator mounting screws to be removed and for the

actuator to be slid out from under the brake pressure booster and alongside the radiator.

Figure 29 - Elevation view of temporarily deformed mounting bracket

Please note that the space will still be very tight. There will be a need for some maneuvering of the actuator before it will slide out.

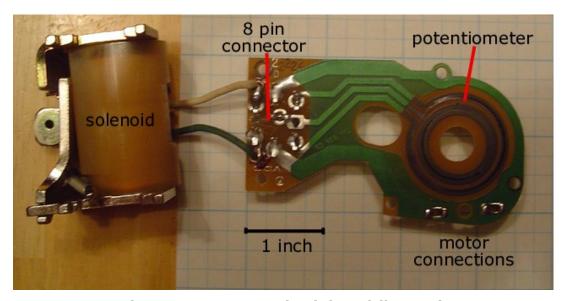
The Cruise Control Actuator has a simple printed circuit board with connections to a potentiometer, motor, solenoid, and eight pin connector. The motor has a measured resistance of 10 ohms and is designed for a 12vdc system. The solenoid has a measured resistance of 33 ohms and is used to engage the motor drive. The potentiometer has a measured resistance of 250 ohms and is used to sense the position of the control cable drum gear.

Figure 30 - Actuator circuit board (bottom)

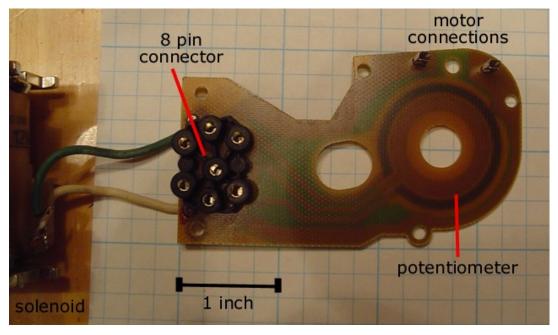
Figure 31 - Actuator circuit board (top)
